Ceramic-on-Ceramic Failure Secondary to Head–Neck Taper Mismatch

Donald W. Hohman, MD, Jesse Affonso, MD, and Mark Anders, MD

Am J Orthop. 2011;40(11): 571-573. Copyright Quadrant HealthCom Inc. 2011. All rights reserved.

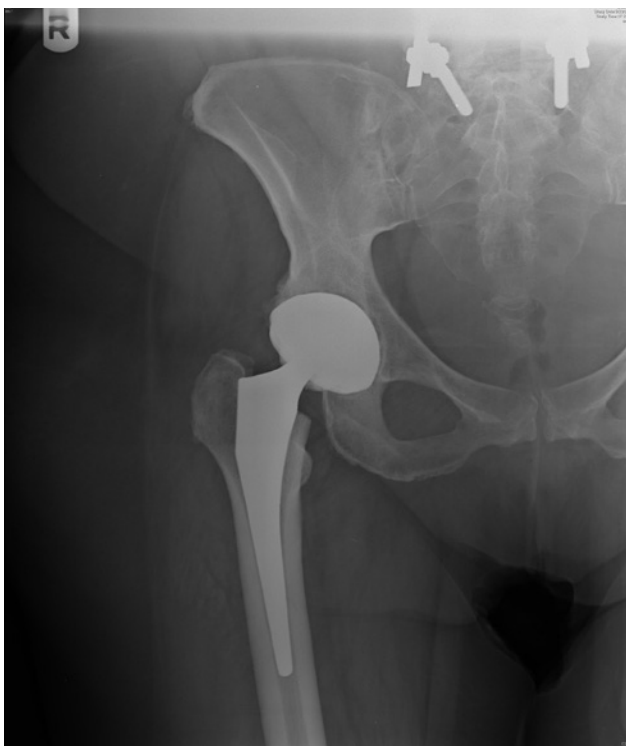
In January 2005, a 64-year-old woman (weight, 154 lb) underwent uncemented right total hip arthroplasty (THA) for degenerative osteoarthritis. Components used were Trident PSL Acetabular Shell/52E, Trident 0° Alumina Insert/32E, Accolade TMZF Plus Hip Stem, and Alumina C-Taper Head 3200E (all manufactured by Stryker Howmedica, Kalamazoo, Michigan). The operation was performed without complication at an outside institution. There were no reported perioperative complications, and the patient reported doing well during the initial postoperative period. At 6- and 12-month evaluations, she had no pain symptoms and hip motion was excellent (Figure 1).

Figure 1. Radiograph 12 months after index procedure shows no obvious implant malpositioning or signs of failure.

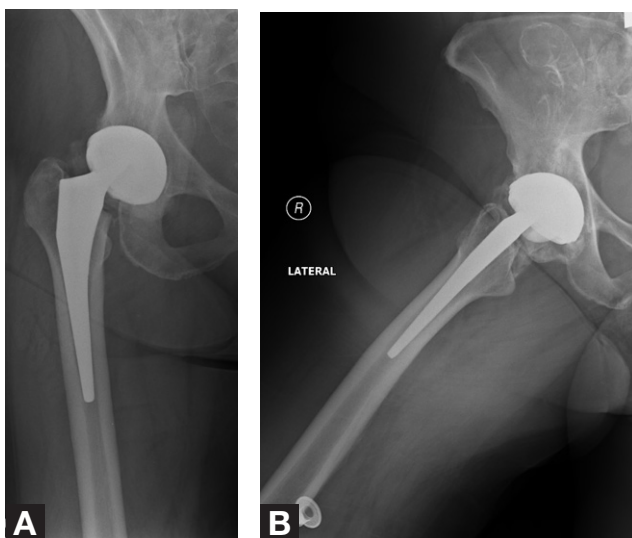
In December 2008, the patient was evaluated at our institution for right groin pain and crepitus with no history of trauma. Radiographs showed signs of implant failure (Figures 2A, 2B).

Figure 2. Anteroposterior (A) and lateral (B) radiographs completed approximately 36 months following the index procedure demonstrating signs of implant failure.

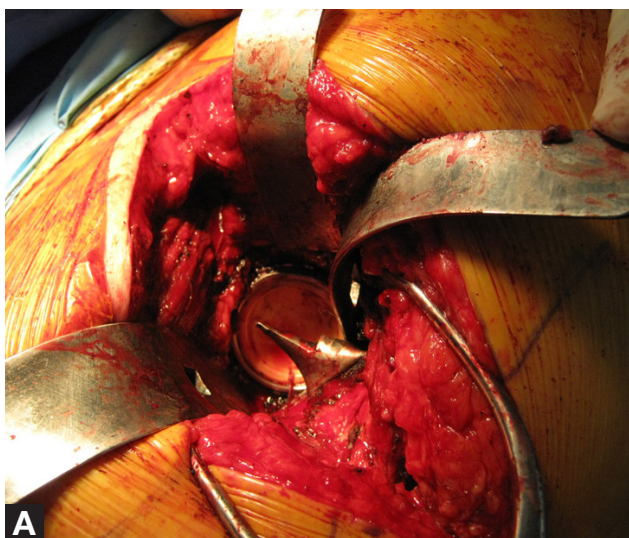
Given the patient's clinical presentation and the radiographic signs of hardware failure, revision surgery was performed. Intraoperative findings included diffuse metallosis, a pseudocapsule containing black metalloid fluid, excessive wear of the trunnion, and no appreciable wear of ceramic head and liner (Figures 3A, 3B). The uncemented stem and the acetabular component were stable. The THA was revised to a modular prosthesis with a bearing surface of metal on highly cross-linked polyethylene. Review of the operative reports revealed that, during the initial component selection, an alumina head of incorrect size was chosen. An alumina V40 head would have been the appropriate match for the implanted stem and trunnion.

In our patient's case, component mismatch led to accelerated wear and subsequent revision surgery. The rapid component deterioration can be explained by the fact that the contact area of the trunnion taper and the femoral head was much smaller than normal because of incongruence and taper mismatch. The V40 alumina head would have been the appropriate match for the implanted stem. The femoral head initially used was designed for the neck of a C-taper stem, which is more robust proximally. The head that should have been used would have accommodated the V40 neck geometry, which is much more slender proximally. The V40 neck is smaller than the C-taper in cross-section. A V40 femoral implant has a smaller neck diameter and, as a result, lowers bending stiffness. In the mismatch scenario presented here, the contact stress of the trunnion was increased. The ultimate result observed is that of altered mechanics and accelerated component wear. Multiple taper options result in flexibility for optimal component

Figure 3. (A) Intraoperative findings included diffuse metallosis, and excessive wear of the trunnion. (B) At the time of implant removal, there was no appreciable wear of the ceramic head and liner.

Under normal loading conditions, contact stress at the hip joint may be multiple times that of body weight. In our patient's case, the resulting rapid deformation of the trunnion surface increased the altered surface area contact and resulted in rapid wearing of the component. This patient's observed results corroborate other authors' speculations that severe wear may result from size and angle mismatches involving femoral heads and taper locks.⁵ Perhaps more important, during our patient's operation, the ceramic head was rotationally free on the neck. A free-spinning ceramic head on a titanium-alloy stem would lead to excessive wear of the stem.

ceramic head was rotationally free on a softer titanium-alloy stem—which created a “sharpening” effect as the head wore down the soft stem, ultimately leading to rapid implant failure. The main options for revision are ceramic-on-ceramic, followed by ceramic-on-highly cross-linked polyethylene, followed by metal-on-highly cross-linked polyethylene.⁷ Obviously, during revision surgery, a ceramic ball cannot be safely placed on such a severely damaged trunnion. Given the need to revise both femoral and acetabular components and the associated bone loss, we used modular revision components with bearing surfaces of metal-on-highly cross-linked polyethylene. Ceramic-on-ceramic surfaces represent the foremost option because of their scratch resistance, but, in the setting of extensive metallosis debris, extensive soft-tissue involvement, and an associated reaction, we decided against ceramic. Metal-on-highly cross-linked polyethylene is now used most frequently,⁷ though long-term results are yet to be determined. We avoided metal-on-conventional polyethylene because it has been shown to carry a risk for accelerated wear and the need for early re-revision.^{8,9}
