THE CLINICAL PICTURE

A second-degree burn after MRI

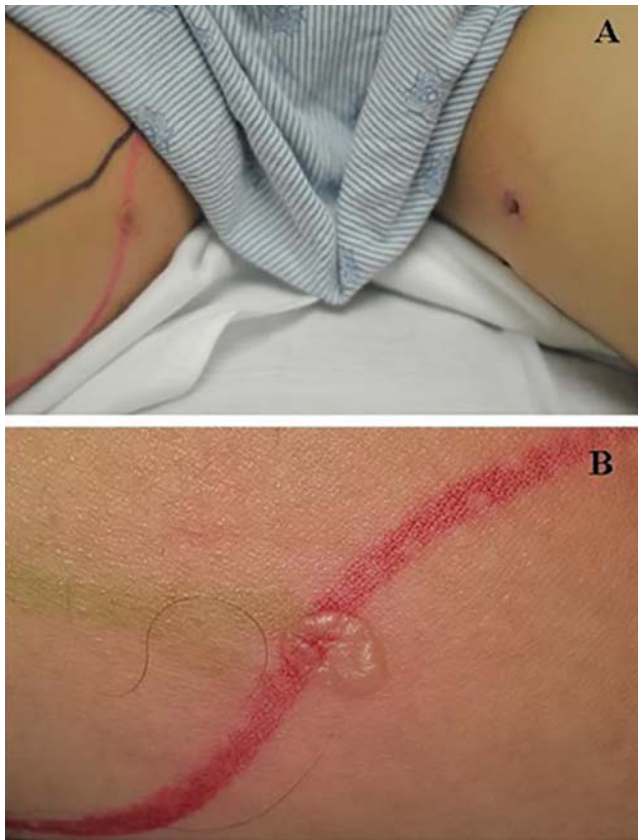
FIGURE 1. (A) Articulating 1-cm lesions developed after magnetic resonance imaging. The black and red tracings on the right inner thigh indicate the original area of cellulitis. (B) A bullous lesion with clear serous fluid on the right medial thigh.

After the procedure, the patient was noted to have a bullous lesion on each thigh, each lesion roughly 1 cm in diameter and filled with clear serous fluid (Figure 1). He reported that his legs had been pressed together before entering the MRI machine and that he had felt a burning sensation in both thighs during the test. Examination confirmed that the lesions indeed aligned with each other when he pressed his thighs together.

Thermal burns are a potential cause of injury during MRI. Most have been observed in patients connected to external metal-containing monitoring devices, such as electrocardiogram leads and pulse oximeters.^{1,2} Thermal burns in patients unconnected to external devices have occurred when the patient's body was touching radiofrequency coils³ or, as with our patient, when skin touches skin.^{2,4,5} Skin-to-skin contact during MRI can cause the scanner to emit high-power electromagnetic radiofrequency pulses that are conducted through the body, creating heat. Tissue loops are created at points of skin-to-skin contact, thus forming a closed conducting circuit. The current flowing through this circuit can produce second-degree burns.⁴

We believe that during placement in the scanner, our patient inadvertently moved his

thighs together, forming a closed loop conduction circuit and resulting in a thermal burn.

This case illustrates the importance of correct positioning during MRI. The MRI technicians had taken standard precautions, placing a sheet over the patient and ensuring no direct contact with the radio-frequency transmitter receiver (MR unit). However, precautions against skin-to-skin contact were not taken, and the patient's legs were not separated.

Appropriate positioning prevents closed skin-to-skin loops, but this may be more challenging in a larger patient.⁶ While the patient is in the scanner, a “squeeze ball” alert system allows the patient to signal the technologist should unexpected distress or heating occur.^{6,7} A patient's inability to utilize the squeeze ball contributes to the risk of a severe injury. Further, in this instance, there may have been a language barrier. Also, proximity of the anatomic skin-to-skin loop to the imaged body part (and therefore the center of the MRI coil) may have conferred risk related to field strength in this patient.

The MRI technologist, under supervision of a radiologist, is primarily responsible for positioning the patient to decrease the risk of this complication and for following institutional MRI safety protocols and professional guidelines.⁶⁻⁸ MRI technologist certification training highlights all aspects of safety, including skin-to-skin conducting loop prevention.^{7,8}

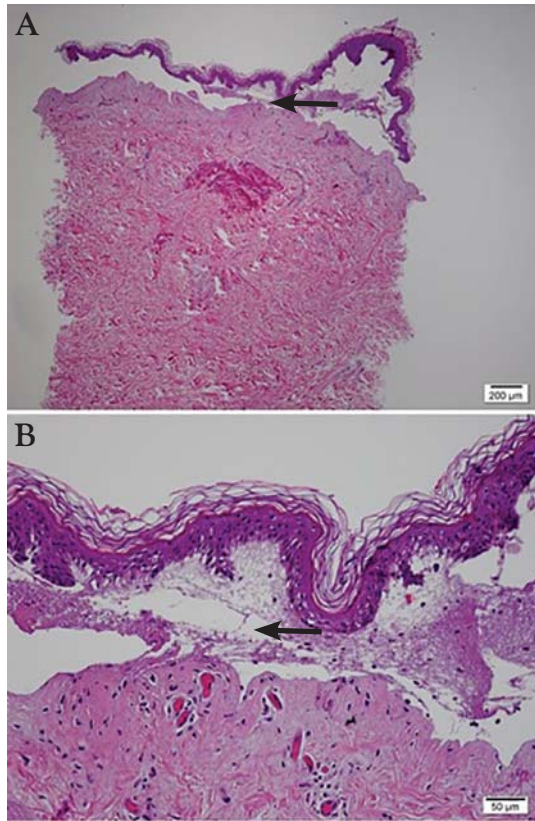
Study of a biopsy of one of the lesions revealed subepidermal cell blisters with focal epidermal necrosis and coagulative changes in the superficial dermis, consistent with a thermal injury (Figure 2).

FIGURE 2. Focal epidermal necrosis (arrows) and coagulative changes in the superficial dermis were consistent with thermal injury (hematoxylin and eosin; panel A magnification × 2.5; panel B magnification × 10).
