## After a Need for Speed, a Spine Entwined?

Nandan R. Hichkad, PA-C, MMSc

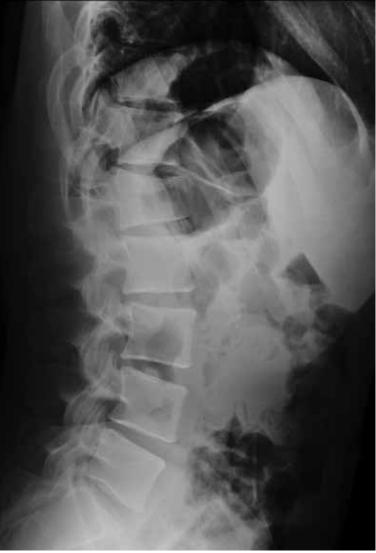
As you await lab results, you obtain a lateral radiograph of the lumbar spine (shown). What is your impression?

The radiograph demonstrates a comminuted fracture of the superior end plate of L1. There is a loss of height of about 20% to 25%.

Of note, there is a lucency that appears to extend horizontally through the pedicles and into the spinous process. If this observation is accurate, then the patient would have a three-column injury. Such fractures are known as *Chance fractures*, and they are typically unstable and require operative intervention for stabilization.

Chance fractures are better visualized on CT. Subsequent testing confirmed a Chance fracture at the L1 level. The patient was admitted, and neurosurgical evaluation was requested. **CR**
