Failure of the Vari-Angle Hip Screw System: Two Cases

Philip Daniel Nowicki, MD, and Gregory Minas Georgiadis, MD

The literature includes few reports on the VHS, and the manufacturer asserted that its biomechanical studies have failed to show any failures of the variable-angle side-plate mechanism.² Here we report 2 cases in which the VHS failed by varus angulation of the side plate after insertion.

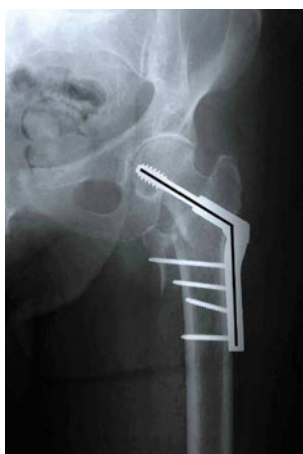
Figure 1. Case 1—Immediate postoperative radiograph of Vari-Angle Hip Screw System (VHS®; Biomet Trauma, Warsaw, Ind) hip screw for treatment of left hip peritrochanteric fracture. Measured implant angle is 120°.

A woman in her mid-80s sustained a left peritrochanteric hip fracture after a slip and a fall. After appropriate medical clearance, she was treated with reduction on a fracture table and insertion of a VHS. Her original postoperative radiographs were felt to show satisfactory fracture reduction and implant position (Figure 1). She tolerated the procedure well and without complications and was allowed to weight-bear as tolerated after surgery. Although her initial recovery progressed without event, 4-month follow-up radiographs showed varus collapse of the side plate without change in the femoral head or shaft fixation (Figure 2). The patient healed with a varus malunion and had shortening of the involved leg. She was treated with a shoe lift and ambulated with a cane 21 months after injury.

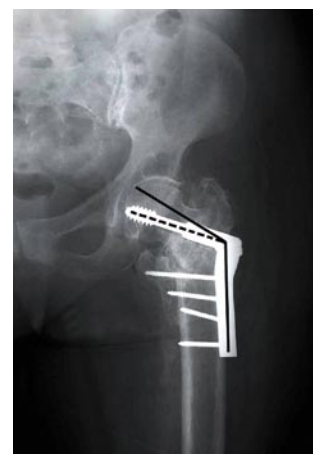
Figure 2. Case 1—VHS at 4-month follow-up showed varus collapse of variable-angle side-plate mechanism without loss of fixation in femoral head or shaft. New angle is 109°.

both cases clearly illustrate that, when used for unstable peritrochanteric fracture patterns, the barrel-side-plate angle of the VHS can collapse into significant varus. This outcome goes against the manufacturer's claims. The precise mechanism that allows for the angle to change without manual adjustment is unclear, but it may involve cyclic, in vivo forces focused at the internal adjustable ratchet mechanism of the implant. This phenomenon does not occur in standard CHS implants. Further study may elucidate a precise mechanism for this failure.

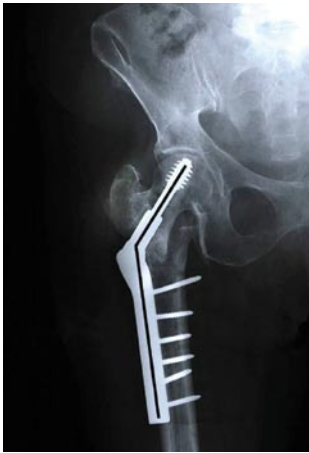
Figure 3. Case 2—Immediate postoperative radiograph of revision open reduction internal fixation with VHS for failed compression hip screw. Angle is 143°.

stabilized with a CHS, but this device failed. The treatment was revised with an open medial displacement osteotomy, autogenous bone grafting, and insertion of a VHS device (Figure 3). The patient returned 2 years later with complaints of increased shortening of the right leg and progressive hip pain. Radiographs at that time, compared with original radiographs, showed some controlled collapse of the lag screw as well as varus collapse of the barrel-side-plate angle (Figure 4). The radiographs also showed femoral head changes consistent with avascular necrosis. The treatment was subsequently revised to a calcar-replacing total hip arthroplasty. Gross inspection of the retrieved implant revealed no obvious deformation or damage, and the barrel-side-plate mechanism was still adjustable.

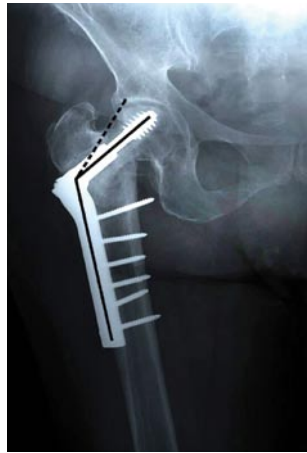
Figure 4. Case 2—At 2-year follow-up, lag screw showed collapse within barrel and clear change in neck-shaft angle of VHS. New angle is 120°.
