Evaluating Factors Affecting Patellar Component Fixation Strength in Total Knee Arthroplasty

Russell A. Wagner, MD, Nathan E. Lesley, MD, René E. Coté, PhD, and Tristan J. Tayag, PhD

Abstract

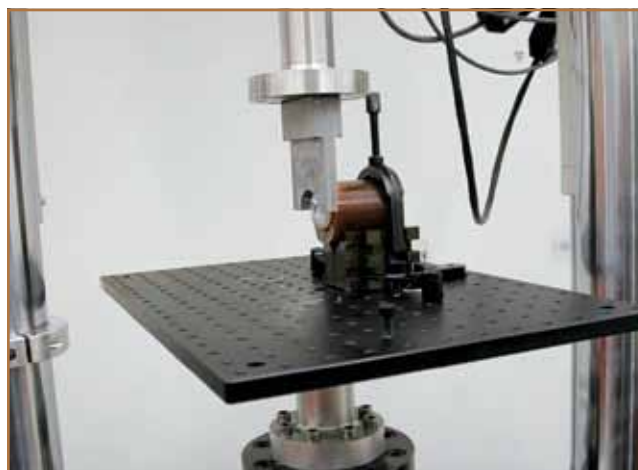
Figure 1. Materials testing machine (MTS; MTS Systems Corp, Eden Prairie, Minnesota) with guillotine-type shear-testing apparatus and patella mounted in polyvinyl chloride pipe.

stress using a guillotine-type device attached to a materials testing machine (MTS; MTS Systems Corp, Eden Prairie, Minnesota), which fits concentrically over the superior portion of the patellar component (Figure 1). Attached to the load cell was a base plate on which a V-block specifically designed to hold the patella–Bondo construct was placed. The testing machine was set to perform an axial displacement of 5 mm per minute. A compressive force was then applied directly to the patellar implant. The load–displacement curve was recorded until failure occurred at the bone–cement interface. Resulting curves and peak stress pressures were analyzed to determine which pressures and curing times provided optimum fixation strengths.

The patellae were mounted individually to test them for fixation strength. Polyvinyl chloride (PVC) pipe measuring 2 inches in diameter was cut into pieces 2.5 inches long, and cellophane tape was applied to one end of each piece to create a watertight seal. Then, PVC pipe measuring 1 inch in diameter was cut to an appropriate length to create a pedestal (to be placed in the wider pipe) for the patellar construct. The length of the pedestal was measured such that the patellar bone was submerged in the 2.5-inch PVC pipe with the polyethylene component exposed and parallel to the top of the pipe. The patellar construct was kept from rocking on the pedestal first by placing 3 small (4×4-mm) balls of putty (Play-Doh; Hasbro, Pawtucket, Rhode Island) on top of the pedestal. The pipe was then filled with adhesive (Bondo 432; 3M, St. Paul, Minnesota), which the manufacturer recommended for this experiment. The resulting construct was then left to dry overnight before testing.

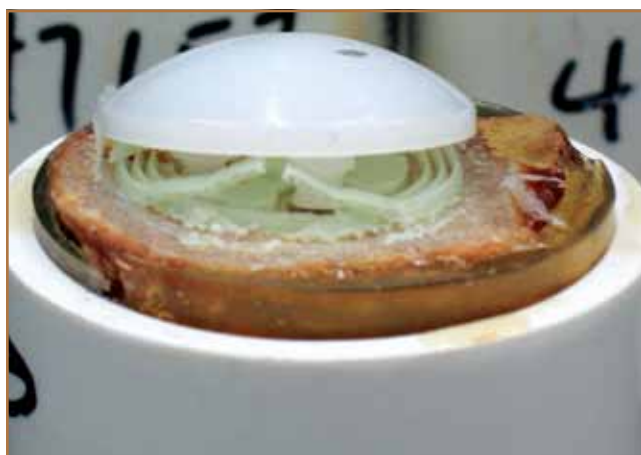
Figure 2. Patella with patellar component after shear testing.

bone. We were seeking to identify factors that increase the strength of the cement fixation and used the offset yield as the failure point in this study (Figure 2).

We consistently identified 2 points of failure. The first point is the offset yield point. We define this as a noticeable horizontal change in the slope of the stress/strain curve, indicating failure occurring at the cement mantle. Plastic deformation occurs here because the polyethylene pegs are abutting cancellous patellar bone. Therefore, more force is required to cause complete failure of the patellar construct. Gross examination of the specimens at the offset yield point confirms this definition, as we were able to identify cracks in the cement mantle, while still having the patellar component firmly seated within the

The second failure point, peak offset, is the point at which the slope of the stress/strain curve becomes negative, and the patellar component completely dissociates from the bone. Here we noticed that either the pegs bent, allowing them to come out of the bone, or the patellar bone failed and the implant was dislodged. However, we did not witness any fracture occurring at the peg-plate junction, as has been reported to occur *in vivo*.⁷⁻¹⁰

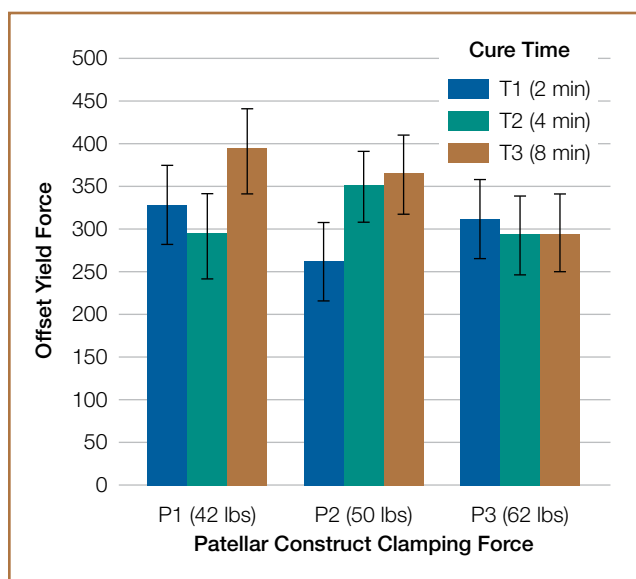
Figure 3. Graph of results of shear testing.

2 minutes the difference in shear force, 359 pounds at 42 pounds versus 328 pounds at 50 pounds, was significant ($P = .005$) (Figure 3).

On our a priori assumption, we performed a series of unpaired t-tests between pairs of cells at curing times T1 (2 minutes), T2 (4 minutes), and T3 (8 minutes), and compared the 3 times within each of the pressures P1 (42 pounds), P2 (50 pounds), and P3 (62 pounds). Analyzing the differences between the patellar constructs at each curing time across all 3 distinct pressures, we found a trend toward stronger fixation with longer curing time, and at 50 pounds of pressure the difference in shear force, 366 pounds at 8 minutes versus 261 pounds at 2 minutes, was significant ($P = .006$). In addition, there was a trend toward stronger fixation with lower pressure, and at

The results of this investigation demonstrated that component fixation was significantly stronger after curing the cement for 8 minutes than for 2 minutes. This finding is contrary to our hypothesis. We now theorize that cement of a firmer consistency could force penetration into cancellous bone and may have less extrusion, thereby avoiding a thin, weak cement mantle. After 8 minutes, the cement begins to harden at an accelerated rate, becoming more difficult to eject from the applicator. Furthermore, 42 pounds of pressure yielded stronger fixation than 62 pounds of pressure did, consistent with our initial hypothesis.
