# Crusted Lesion at the Implantation Site of a Pacemaker

Catherine E. Lyons, BS, BA; Aaron D. Smith, BS; Lydia A. Luu, MD; Barrett J. Zlotoff, MD

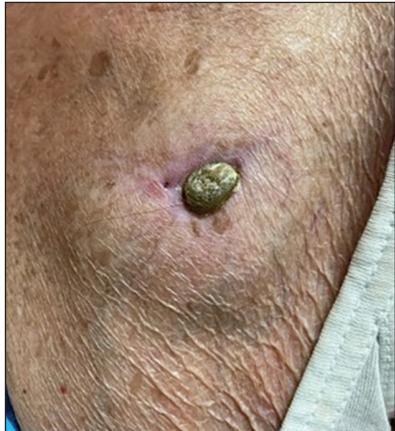
A 78-year-old woman was referred to dermatology from the cardiology clinic with concerns of a nonhealing, scablike lesion on the left chest over the implantation site of a dual-chamber permanent pacemaker (PPM). Eight months prior, the patient underwent successful PPM implantation for symptomatic bradycardia and second-degree atrioventricular block. Her cardiologists subsequently noticed an oozing crusting scab at the site of implantation and eventually referred her to dermatology with concerns for squamous cell carcinoma. Physical examination at the current presentation revealed an exophytic serous crust overlying the PPM implantation site on the left chest.

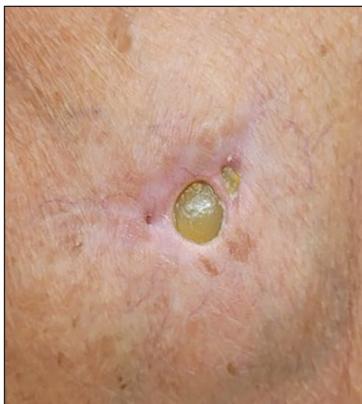
The lesion crust was easily scraped away to reveal extrusion of the permanent pacemaker (PPM) through the skin with a visible overlying gelatinous biofilm (Figure). The patient subsequently completed a 2-week course of clindamycin 300 mg 3 times daily followed by generator and lead removal, with reimplantation of the PPM into the right chest, as is the standard of care in the treatment of pacemaker extrusion.<sup>1</sup>

**FIGURE.** After gentle removal of the superficial crust, the underlying pacemaker generator was exposed through the epidermis, with a visible gelatinous biofilm coating the device surface, confirming pacemaker extrusion through the skin.

Ours is the first known reported case of pacemaker extrusion referred to dermatology with a primary concern for cutaneous malignancy. Pacemaker extrusion through the skin is not common, but it is the most common complication of PPM implantation, followed by infection.<sup>1</sup> Pacemaker extrusion results from pressure necrosis and occurs when the PPM emerges through erythematous skin.<sup>1,2</sup> Pacemaker extrusions generally are diagnosed by cardiology; however, it is important for dermatologists to recognize this phenomenon and differentiate it from other cutaneous pathologies, as the morphology of skin changes related to pacemaker extrusion through the skin can mimic cutaneous malignancy or other primary skin disease, especially if the outer layer of a biofilm that forms around the PPM hardens to form a crust. Our case emphasizes the importance of removing crusts when evaluating lesions.<sup>3</sup>
