## THE CLINICAL PICTURE

### FATIMA ADHI, MD

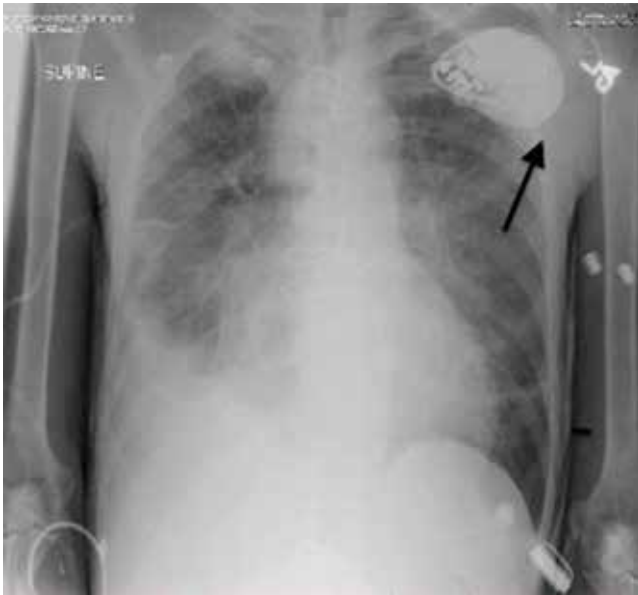
**FIGURE 3.** Chest radiography showed that the generator had rotated 90 degrees and the lead had completely wrapped around the generator (arrow).
