Massive Baker Cyst Resulting in Tibial Nerve Compression Neuropathy Secondary to Polyethylene Wear Disease

Thomas F. Moyad, MD, MPH

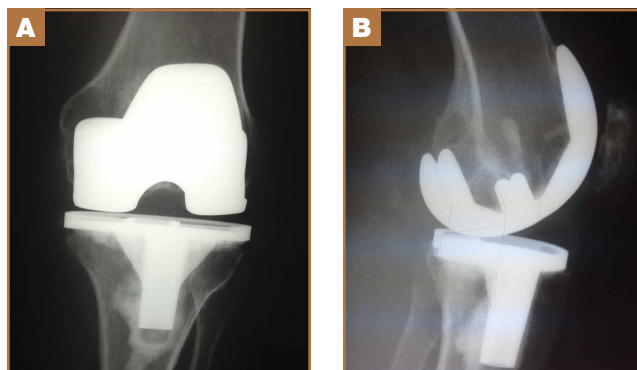
Radiographs showed evidence of asymmetric polyethylene wear on the medial side of the knee (Figures 1A, 1B). Serum

Figure 1. (A) Anteroposterior and (B) lateral radiographs showing a well-fixed total knee arthroplasty with asymmetric polyethylene wear on the medial side.

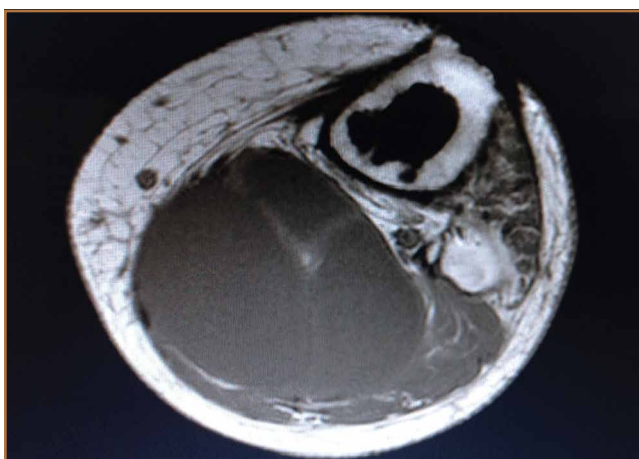
Figure 2. Magnetic resonance imaging of the left leg showing a massive Baker cyst. Note the presence of a large, homogenous fluid-filled mass immediately posterior to the tibia on T1-weighted imaging.

labs were ordered to evaluate for infection. C-reactive protein was mildly elevated at 5.5 mg/L (normal range, 0-5 mg/L); however, the erythrocyte sedimentation rate was normal at 12 mm/h (normal range, 0-20 mm/h). Magnetic resonance imaging of the left lower extremity with intravenous contrast showed the presence of a very large Baker cyst contained within the posterior compartment of the knee and a smaller surrounding cyst adjacent to the popliteal neurovascular bundle (**Figure 2**).

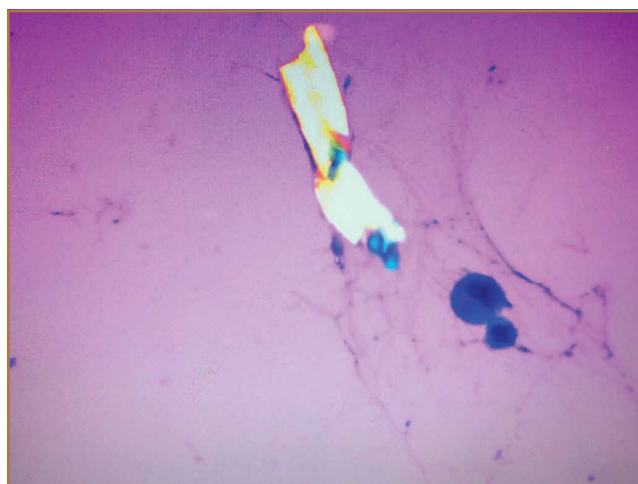
Figure 3. Histologic examination using polarizing light filters. Note the positively birefringent amorphous material consistent with high-molecular-weight polyethylene debris.

The Baker cyst was re-aspirated in the office. The automated synovial fluid cell count could not be performed because of high fluid viscosity. However, a manual review of the fluid specimen under light microscopy revealed proteinaceous, viscous tan-colored fluid containing no neutrophils and a few macrophages. Fluid cytology was also sent for review under polarizing light microscopy as described by Peterson and colleagues.¹ Scattered fragments of polarizable foreign material were consistent with polyethylene debris (**Figure 3**).

Polyethylene wear debris within the synovial fluid or tissue of failed TKAs can be identified with scanning electron microscopy or by light microscopy utilizing polarized light.¹ In this particular case, wear debris was confirmed within the synovial tissue and in the fluid of the Baker cyst by microscopic analysis.

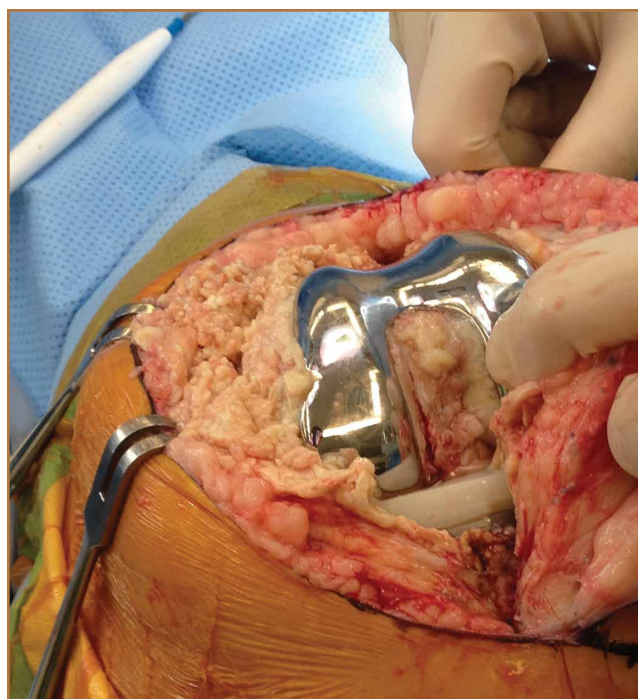
Figure 4. Hypertrophic synovitis secondary to polyethylene wear disease.

During surgery, the knee joint exhibited hypertrophic synovitis with a characteristic pale-yellowish discoloration secondary to significant polyethylene wear disease (**Figure 4**). The polyethylene liner was severely worn with pitting, cracking, and delamination (**Figure 5**). While the patellar component was grossly loose, the tibial and femoral components were stable. After a complete synovectomy, the loose patellar component and tibial polyethylene liner were replaced. Osteolytic areas within the tibia underwent curettage and allograft impaction

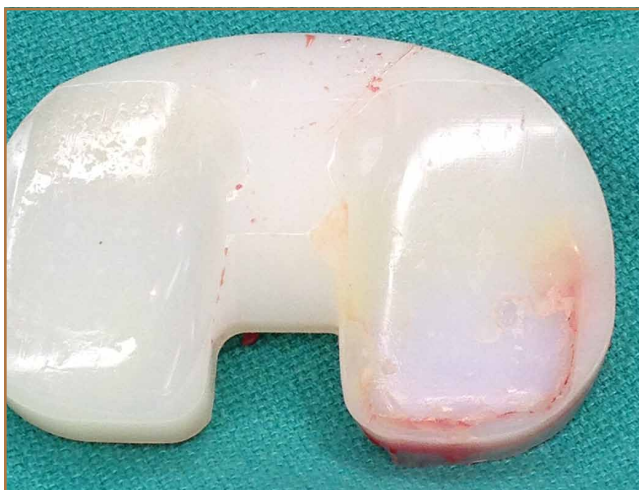
Figure 5. The modular tibial liner shows severe wear including pitting, cracking, and delamination.

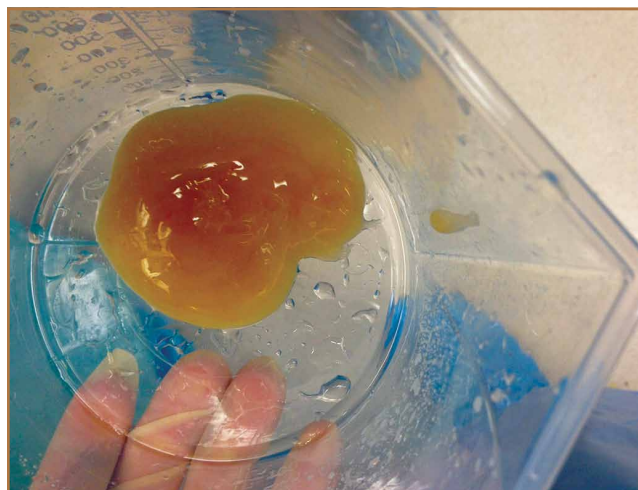
Figure 6. Thick “tapioca pudding–like” synovial fluid aspirated from the Baker cyst at the time of revision surgery.

grafting. Lastly, decompression of the ruptured Baker cyst was performed via a 16-gauge needle placed in the posterior compartment of the left leg. The calf was gently squeezed with a “milking” maneuver, which yielded approximately 200 mL of thick, mucoid yellowish-brown synovial fluid resembling tapioca pudding (Figure 6).
