# Rotating Hinge Distal Femur Replacement: A Turn for the Worse

*Fed Pract.* 2022;39(1).  
Published on January 12.  
doi:10.12788/fp.0212

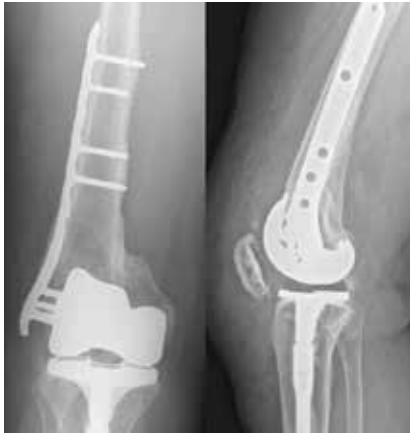
**FIGURE 1** Initial Anteroposterior and Lateral Radiographs

Healed periprosthetic distal femur fracture with golf club deformity can be seen.

A patient with a history of hypertension, osteopenia, and rheumatoid arthritis underwent a primary right TKA in 2007. Ten weeks postoperatively, the patient had a ground-level fall that resulted in a right periprosthetic supracondylar distal femur fracture that was treated with a distal femur locking plate. The patient healed, however, with a significant golf club deformity (Figure 1). The patient did well for more than a decade but in 2019 was admitted with pelvic inflammatory disease and adnexal abscess that was treated with broad-spectrum IV antibiotics. Shortly after this admission, the patient developed a right knee periprosthetic infection with cultures positive for *Ureaplasma parvum*.

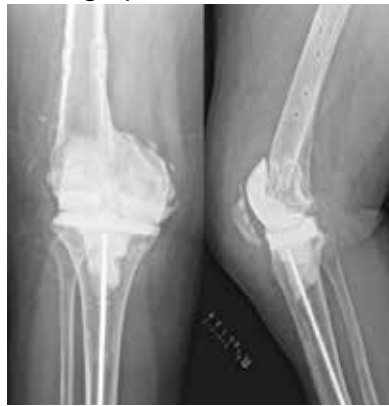
**FIGURE 2** Postoperative Anteroposterior and Lateral Radiographs

First stage revision with articulating antibiotic cement spacer are visible.

The patient then underwent a 2-stage revision of the infected TKA. Stage 1 consisted of explant of the TKA components as well as removal of the distal femur plate and screws and placement of an articulating antibiotic cement spacer (Figure 2). The patient completed 6 weeks of IV antibiotics. Following completion of the antibiotic course, we obtained a serum erythrocyte sedimentation rate, C-reactive protein level, and white blood cell count, which were all within normal limits. A knee aspiration was performed and did not show signs of residual infection. Frozen histopathology was sent

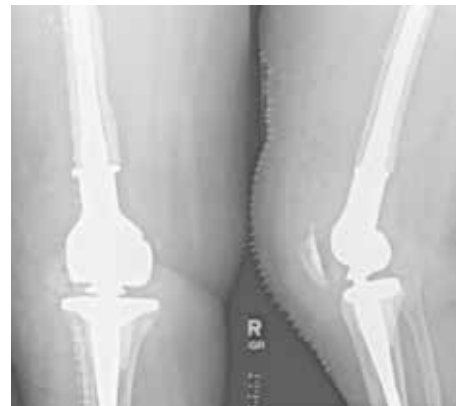
**FIGURE 3** Immediate Postoperative Anteroposterior and Lateral Radiographs

After Zimmer Biomet Orthopedic Salvage System distal femur replacement.

The femoral canal was reamed until good cortical chatter was obtained at 16 mm. Per the Biomet OSS guide, “For bowed (curved) long and short press-fit stems, the final flexible reamer shaft diameter may need to be larger than the definitive trial and implant diameter.” After trialing, size 15.5 mm was selected for implantation. Intraoperatively the final stem was noted to have good interference fit after insertion and was stable throughout knee range of motion and varus/valgus stress testing. The patient did well with mobilization while in the hospital postoperatively and was discharged home (Figure 3).

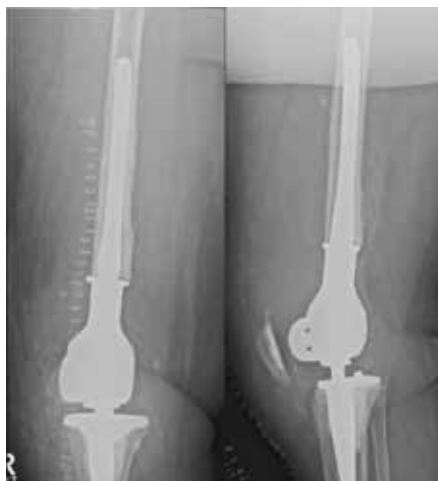
**FIGURE 4** Anteroposterior and Lateral Radiographs

Five days after discharge, the patient kicked the repaired knee onto a chair for rest and elevation and experienced extreme pain and was unable to flex the knee. On presentation to the emergency department, the X-rays showed 180° rotation around the longitudinal axis of the

femoral component without any other obvious component failure or fracture (Figure 4). The patient was taken back to surgery the following day. Intraoperatively, the femoral stem was found to be loose and rotated 180° (Figure 5). No failure or dislocation of the tibial or rotating hinge components were identified. The press-fit femoral stem was removed and replaced with a cemented stem (Figure 6).

180° rotation of the femoral component around its longitudinal axis can be seen.

The implant used in this case was a curved press-fit short-stem DFR. It was thought that this patient was young and with good enough bone quality that a press-fit short stem would be best in preserving bone stock. Both the technique guide and literature support reaming 0 to 2 mm greater than the planned stem size to accommodate the implant curvature.<sup>13</sup> In this case, the intramedullary canal was reamed 0.5 mm larger than the curved stem that was implanted (16 mm and 15.5 mm, respectively). Intraoperatively

during the index DFR, the component was stable and seemed to have a good press-fit interface. Despite this, obvious loosening of the component occurred with a relatively low-energy mechanism when the patient kicked the leg onto a chair, causing just enough force and femoral rotation to result in 180° rotation of the component.

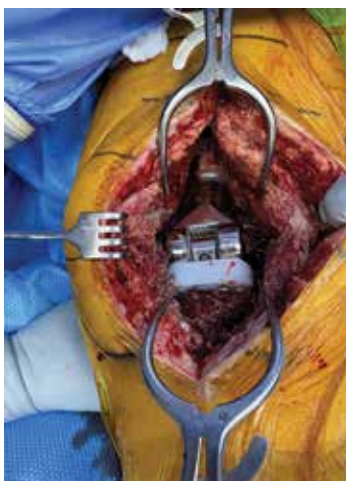
**FIGURE 5** Intraoperative Photograph

Rotated distal femur component is visible.

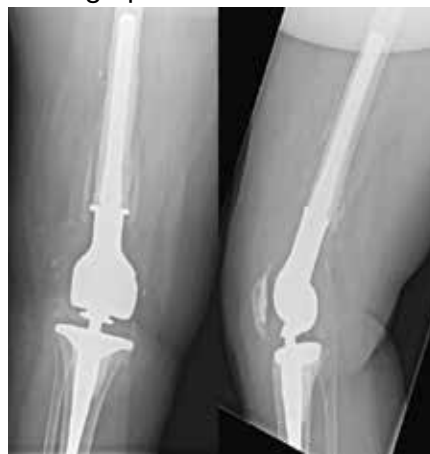
**FIGURE 6** Postoperative Anteroposterior and Lateral Radiographs

Revised cemented Zimmer Biomet Orthopedic Salvage System distal femur replacement.

We present this case report to make surgeons aware of this rare but serious complication. Although the final implant is a porous and curved stem, careful attention should be made during trialing to use the best-fitting implant to prevent this complication. If an adequate interference fit cannot be obtained, cementing the component may be required to prevent its loosening and catastrophic failure.
